CMA ENGINEERS, INC. CIVIL | ENVIRONMENTAL | STRUCTURAL

Re: Philbrick Pond Salt Marsh Drainage Evaluation – Final Report

Philbrick Pond is a 29 acre salt marsh system which drains a small, one square mile drainage area to the Atlantic Ocean through two drainage structures, a culvert beneath Ocean Boulevard, US Route 1A, and a smaller culvert through a 1900 vintage trolley berm.

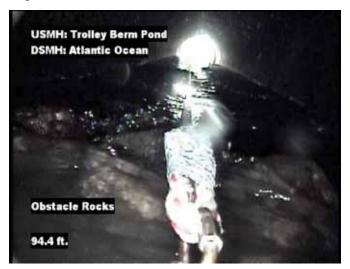
Figure 5

The summary inspection report is presented in Appendix B, and video logs have been provided to NH DOT Division 6 staff. The box section has a field stone side and concrete top.

The box section is about 47 feet long and was reported to be in fair condition (see Figures 5 and 6). There was one section of the concrete top that showed exposed and corroded reinforcing steel, coded as a defect that requires immediate attention. Otherwise, there were several cracks in the top, and indications of previous infiltration, but the box appeared to be fully functional with limited flow obstructions. The 4 foot diameter RCP pipe is 140 feet in length, in good condition with the exception of one joint separation about ten feet from the end of the pipe at the ocean discharge point. There were a number of "obstacle rocks" in the invert of the pipe in the manhole between the box and pipe sections, and in the invert of the pipe to the east of the transition. The nature of these flow obstructions was taken into account in the hydraulic modeling.

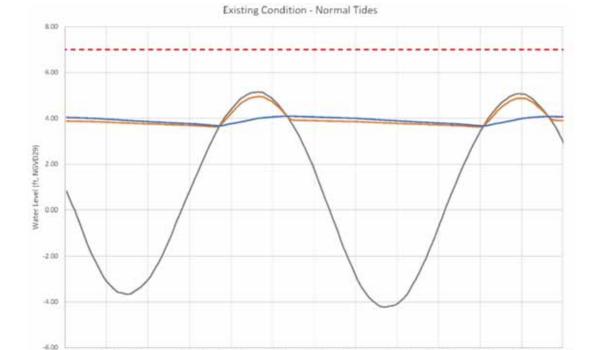
The next step was to evaluate existing conditions, with the 30 inch trolley berm culvert as is (Appendix C.2). Figure 7 presents water levels under normal tidal cycles with existing conditions. The red line is elevation 7.0, where properties and roads begin to flood. The black lines are ocean tide levels. The brown line is the culvert pond elevation, and the blue line is the level in Philbrick Pond. That format will be the same for all graphs to follow. The significant point from this graph is the very limited daily tide variation in the level at Philbrick Pond. While typical tides are varying in the ocean by about 9 feet twice daily, the level in Philbrick Pond only varies by about 5 inches, from a typical high of 4.1 feet to a typical low of 3.7 feet. This is an unusual condition for a saltmarsh, as the level remains constantly within 5 inches of the high tide level.

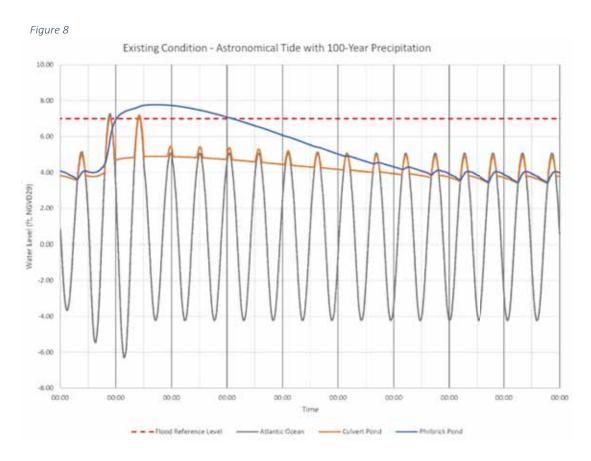
The Philbrick Pond water level predicted by the model under existing conditions in the event of the 100 year storm event is indicated in **Figure 8**. Note that the Philbrick Pond level is above the red flood reference line. As occurred in the Mother's Day storm, this indicates Philbrick Pond would be at a maximum elevation of 7.8 and that the level would remain above the elevation 7 reference flood level for two days. This appears to be accurately modeling what occurred in the 2006 storm.

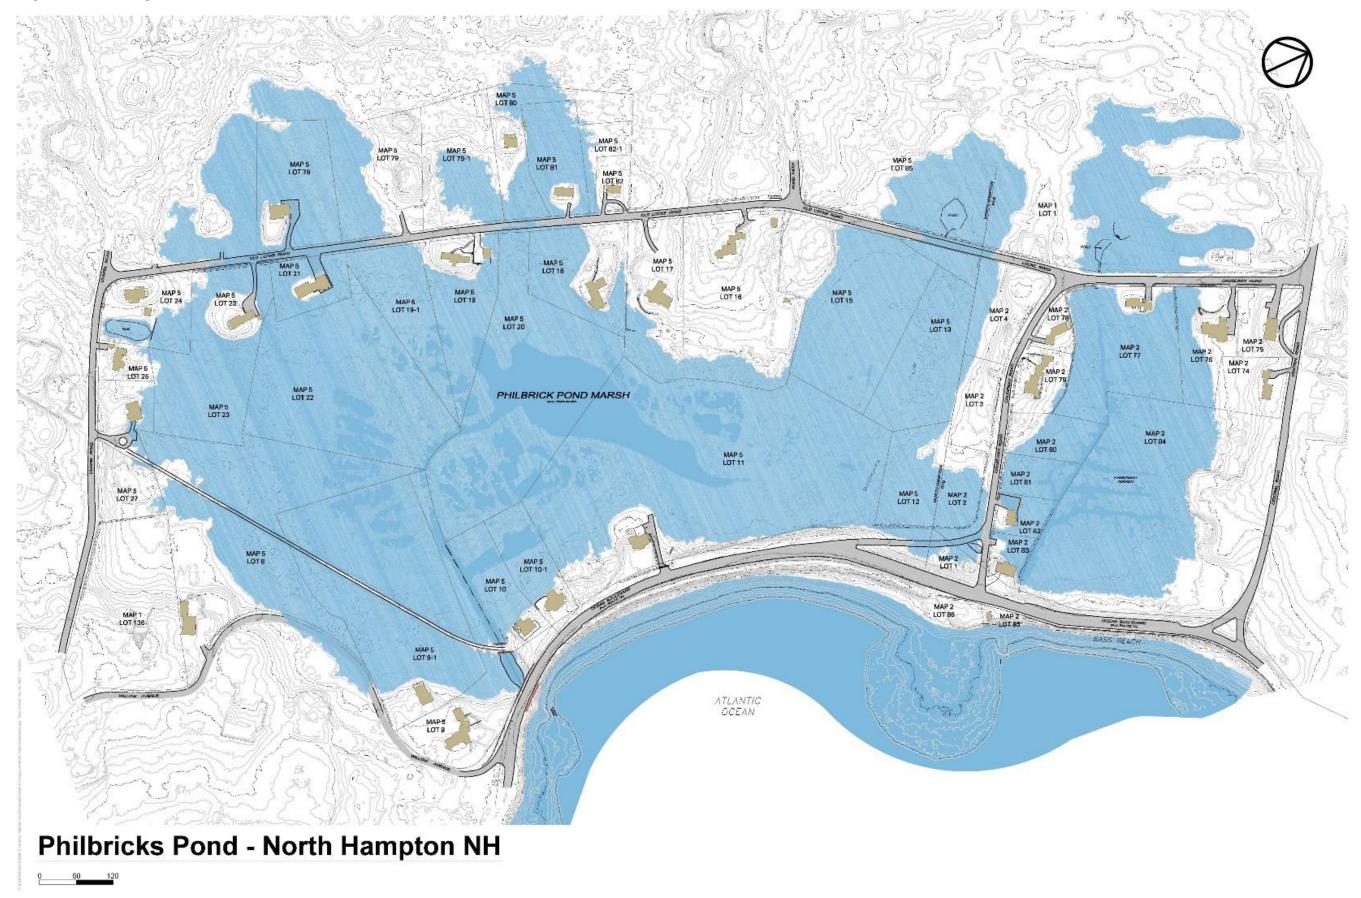
Figure 9 – Flooding Extent Modeled during 100 Year Storm Event

The flooding predicted to occur in the Philbrick Pond neighborhood in the 100 year storm is depicted in **Figure 9**. At the 7.8 level, some basements are subject to flooding, several septic leachfields are under water, but no first floors of houses are flooded. At this level, the primary impact of the flooding is the isolation of houses as Old Locke Road is flooded in several locations at a depth that is impassable to both personal and emergency vehicles. This isolates more than 40 homes for two plus days until water levels subside. That is what occurred in 2006, and that is what the model predicts. This situation will happen again in future major precipitation events, and will be exacerbated in the future by sea level rise.

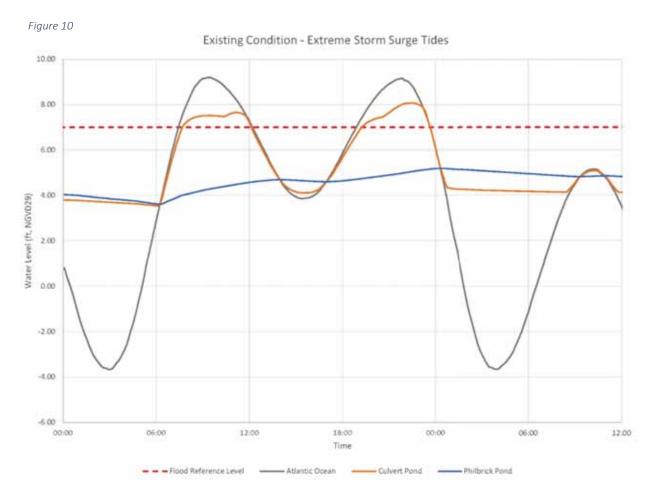
Figure 10 presents the predicted Philbrick Pond level in the event of an extreme storm surge (nor'easter). Note that, under existing conditions (current sea levels, trolley berm pipe as is), the maximum level in Philbrick Pond is only 4.7, a level that does not threaten any properties in the neighborhood. Under current conditions, the flooding risk is solely from precipitation events, and not from ocean storms. Note that the culvert pond level in this circumstance is modeled as being quite high, in excess of elevation 8. However, there is insufficient time of high flow into the pond during a high tide cycle to raise the Philbrick Pond level higher than indicated in Figure 9. This phenomenon has been noticed by neighbors in recent ocean storm events.

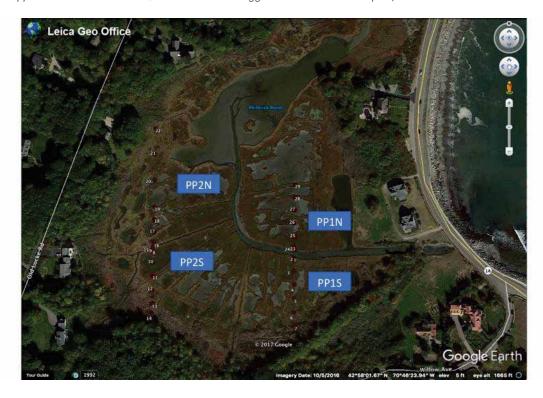
Figure 11 Stations along four transects in Philbrick Pond sampled in 2017. (Figure 2 in Appendix E David M. Burdick, Chris Peter and Gregg E. Moore Wetlands Report)

Philbrick Pond Marsh and Little River Marsh were both assessed as part of the Coastal Program's salt marsh monitoring program at the turn of the century, which involved collections of species composition and abundance of salt marsh plants along transects running from major tidal creeks to the upland edge at randomized locations. Using positions documented in the original database, we re-occupied four transects in each of the two marshes, and collected data in August from 0.5 m2 plots at 1, 10, 50 meters and every 50 meters thereafter up to 200 meters. After 200 meters, 50 or 100 meter intervals were used to obtain seven plots per transect. This resulted in 29 plots at PP (Figure 11) and 28 at LR (Figure 12).

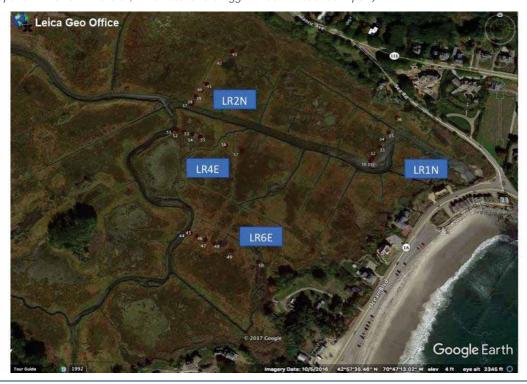
Figure 12 Stations along four transects in Little River Marsh Pond sampled in 2017. (Figure 3 in Appendix E David M. Burdick, Chris Peter and Gregg E. Moore Wetlands Report)

In 2017, our reference site at Little River was dominated by salt hay (38%) but also had a variety of other halophytes summing to 21% cover (Figure 12). In wetter areas tall cordgrass was found and contributed 17% cover. Only 20% cover was dead and bare and 2% cover of invasive species, notably *Phragmites australis* (common reed). In sharp contrast, Philbrick Pond Marsh showed 40% dead and bare, likely due to stressful conditions, and almost twice as much *S. alterniflora*, which is better adapted to the more stressful inundated conditions.

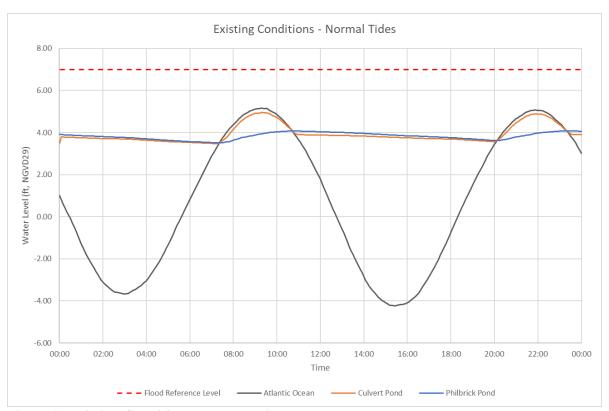
Figure 2: Existing Conditions - Normal Tides

Figures 2 through 4 show the resulting levels of the Atlantic Ocean, Culvert Pond, and Philbrick Pond for each of the three scenarios analyzed. A flood reference level is provided on each figure at 7.0 feet, which is approximately the elevation at which the Old Locke Road begins to flood. It should be noted in Figure 3, that the peak level in the Philbrick and Culvert Ponds are higher than the peak tide due to the inflow from the 100-Year Precipitation. Similar to field observations the model showed that it takes multiple days for the water in the Philbrick Pond to drain after a major rainfall event. The results of a sensitivity analysis, which extends the astronomical tides throughout the simulation, are presented in Figure 5. The sensitivity analysis only increases the peak water level in the Philbrick Pond by about 0.1 feet. It also shows that the duration of the astronomical tides could extend the time it takes to drain Philbrick Pond. While tidal fluctuations of this magnitude may be sustainable for more than one day, they would not last more than a week, as modeled in the sensitivity analysis.

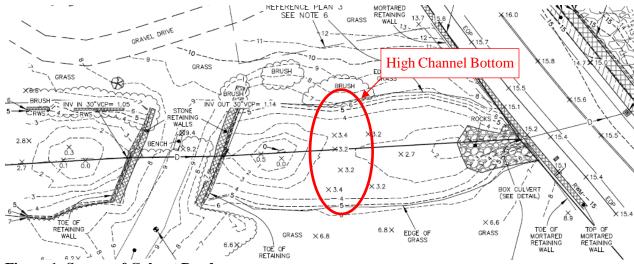
Figure 1: Survey of Culvert Pond

This geometry replaced the "weir" located upstream of the Route 1A culvert with a 4' wide concrete pad at the same elevation as the Route 1A culvert invert (i.e. 2.0 feet). The concrete pad was assumed to be unfinished with a roughness coefficient of 0.017. Additionally, this geometry re-graded the high channel bottom within the Culvert Pond (see Figure 1 below) as this also contributes to reduced outflow.

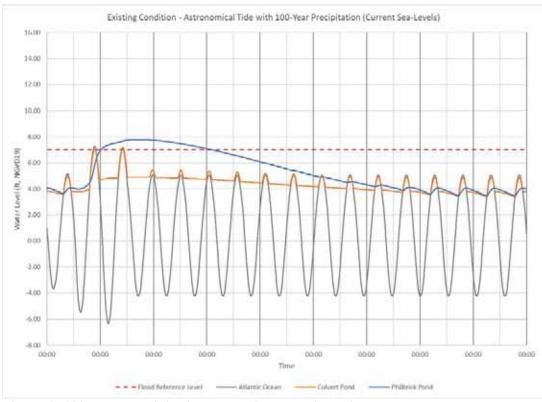
Figure 1: 100-Year Precipitation under Astronomical Tides

Figures 1 and 2 present results of the sensitivity analysis related to the tidal conditions during the peak inflow to Philbrick Pond caused by the 100-year precipitation event. These results show that the normal tides scenario provides a maximum water surface elevation of 7.6 feet as opposed to 7.8 feet under astronomical tides. Additionally, the water recedes below elevation 7 feet approximately 5 hours earlier under the normal tides scenario, which provides earlier access to residences via Old Locke Road.

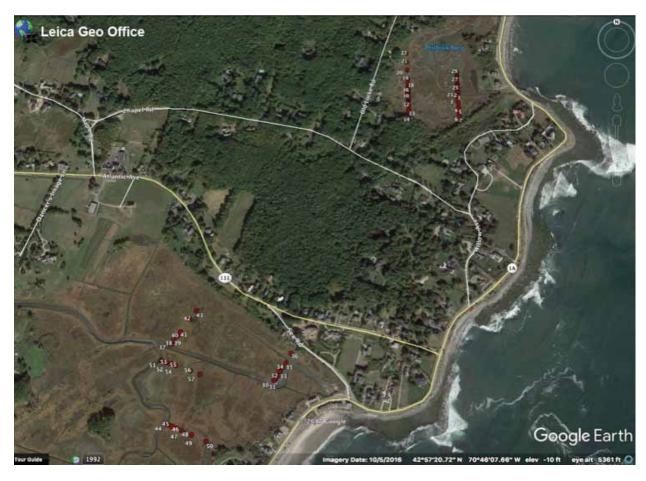
Figure 1. Overview of Philbrick's Pond (upper right) and Little River (lower left); two back-barrier marshes along the Atlantic coast of New Hampshire.

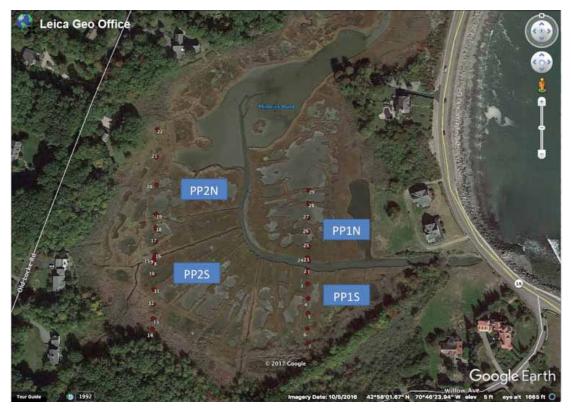
Figure 2. Stations along four transects in Philbrick's Pond sampled in 2017.

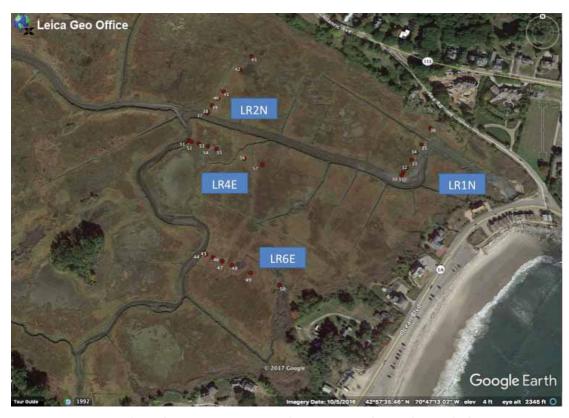
Figure 3. Stations along four transects in Little River Marsh Pond sampled in 2017.
